Fire, Water and Load Tests on  
Berger's *Metal Lumber* System  
(Patented)

Pressed Steel Fireproof Construction

## Test No. 1. (Unofficial)

## Test No. 2. (Official)

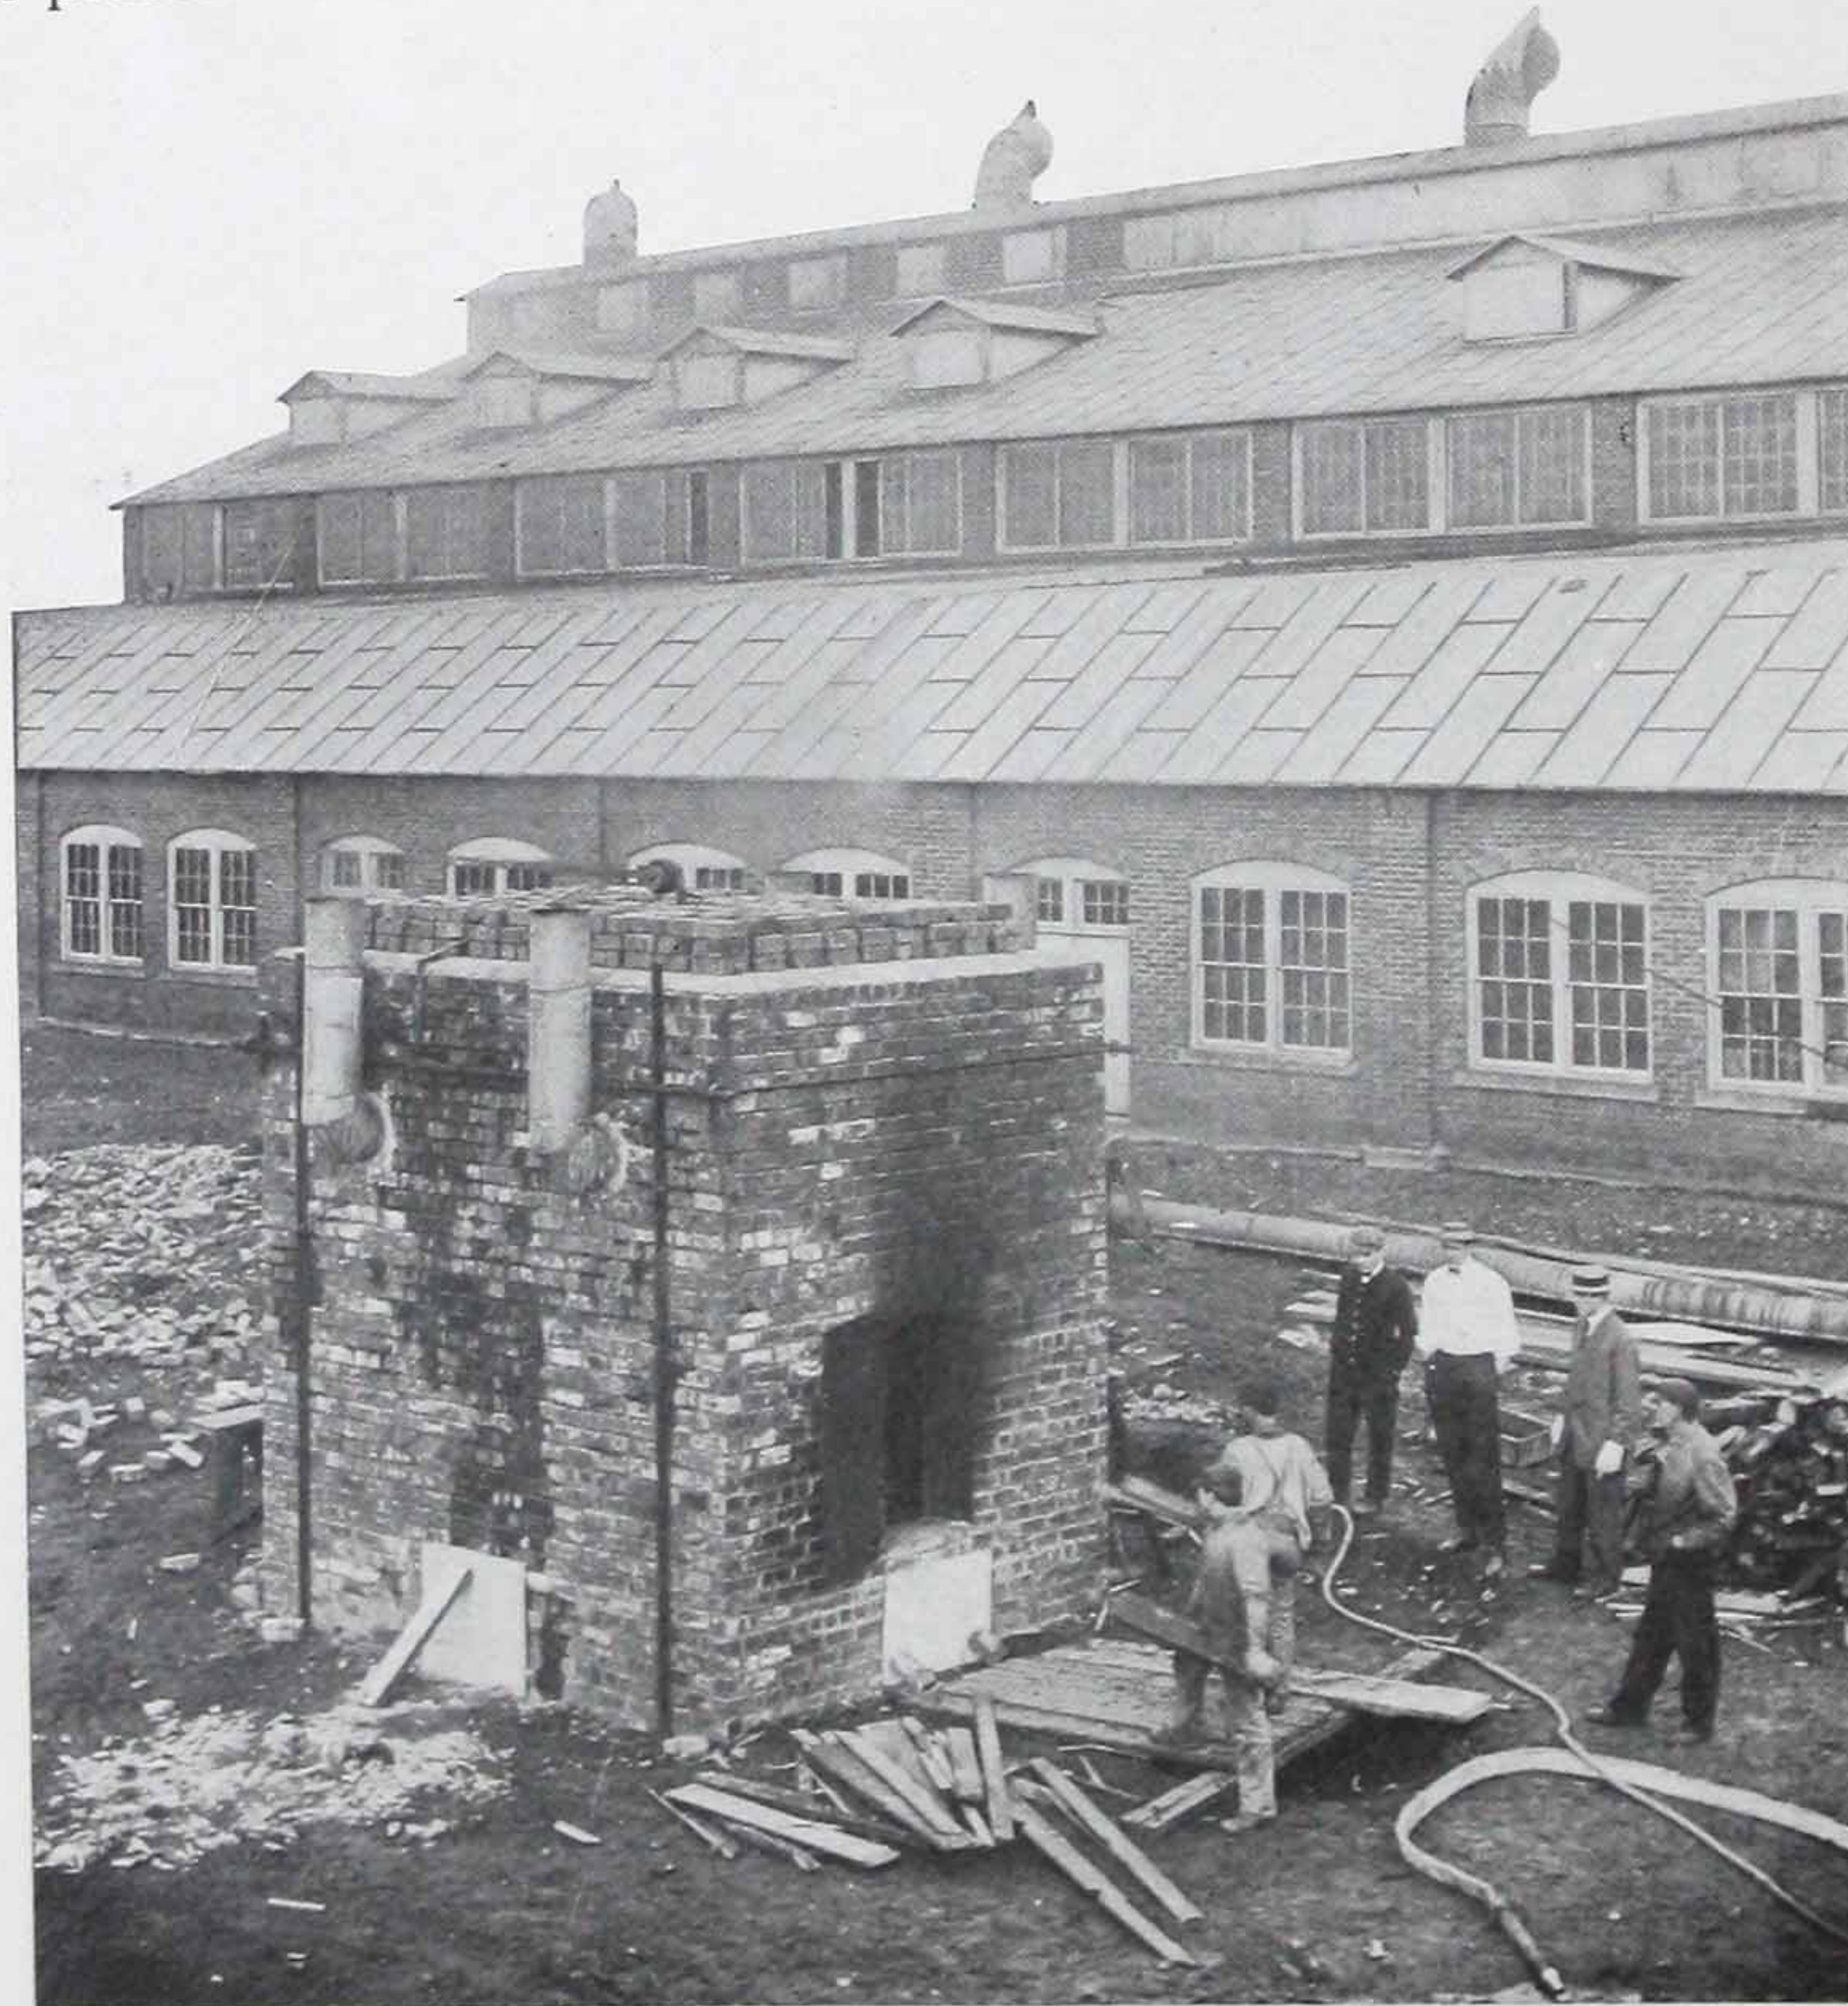
Fire, Load and Water Test on METAL LUMBER System of Fireproof  
Floor Construction. Temperature 2190° F., Five Minutes  
Before Water was Turned In.

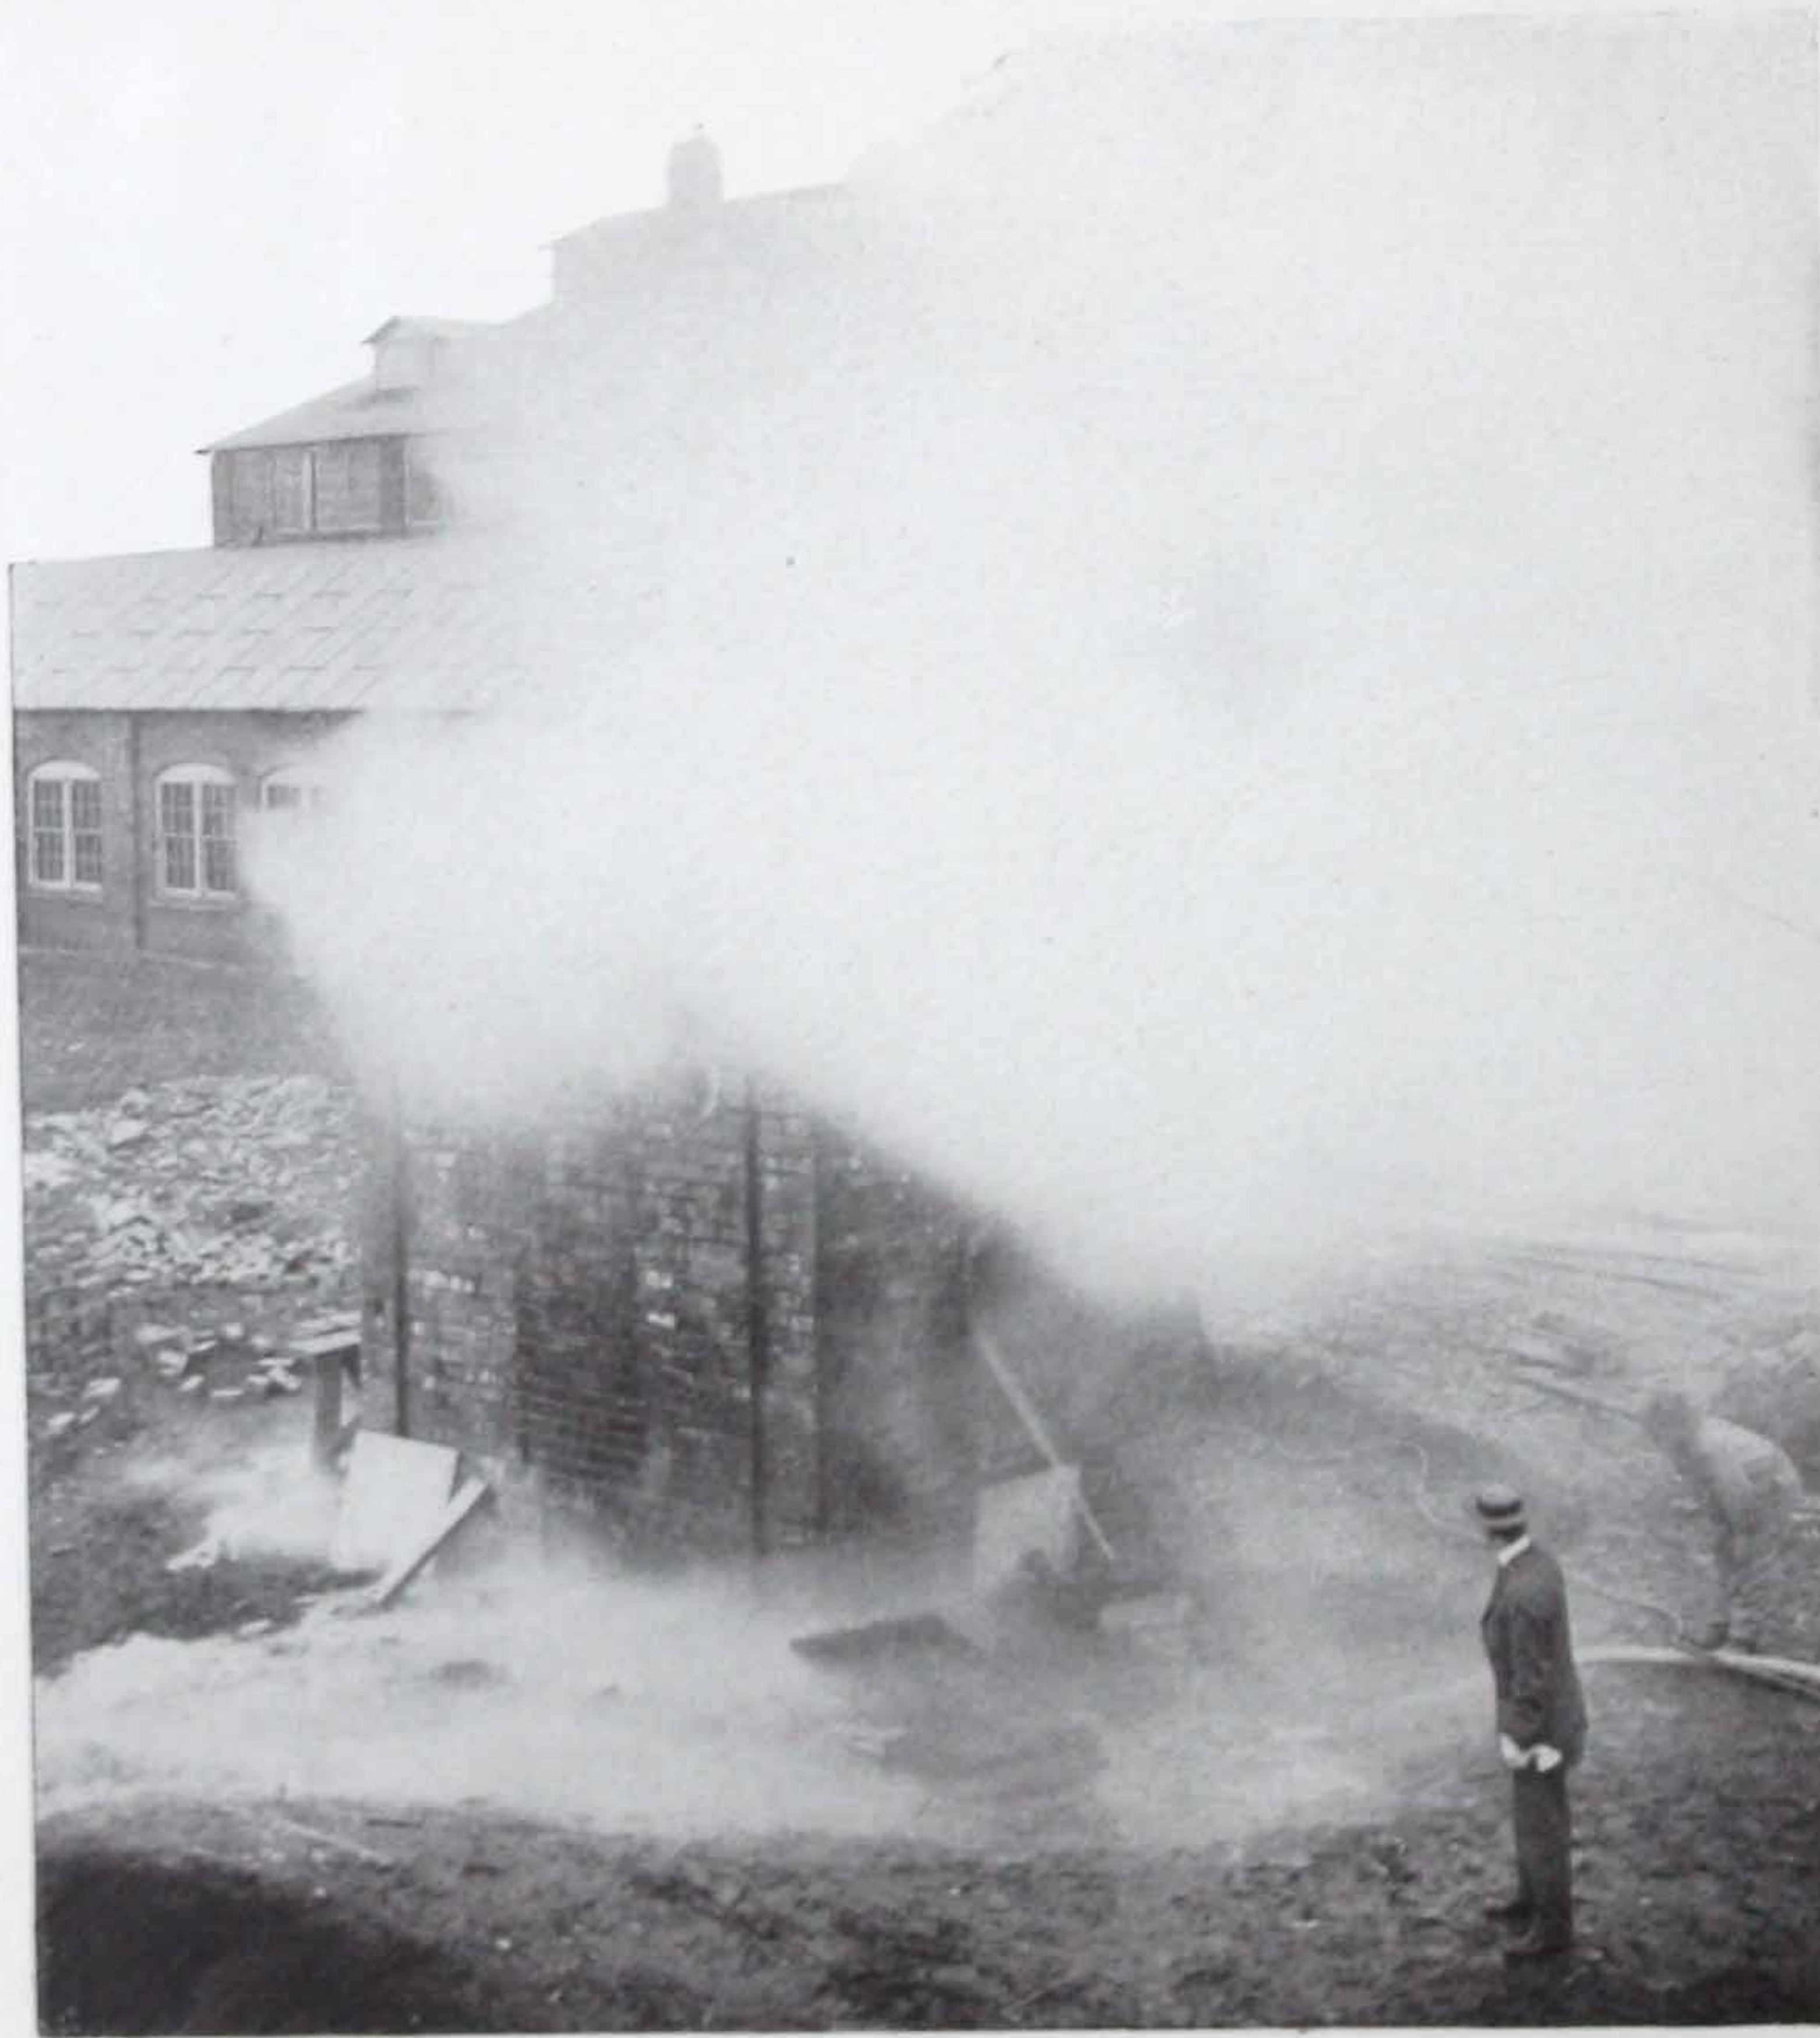
Where the stream of water was applied to the ceiling and allowed to be directed at one spot for a considerable length of time, the plaster was removed, exposing an area of approximately 2 square feet of Expanded Metal Lath. At other points of the ceiling

where it was applied at frequent intervals the second coat of plaster fell off in some cases; but the scratch coat remained wholly intact with the lath completely encased, and on only about one-third of the furnace was the plaster removed at all. In the other two-thirds

of the ceiling area both coats of plaster stayed intact, even though cracks were visible on the under surface. At no time did smoke, fire or water come through the floor.

Fire, Load and Water Test on METAL LUMBER System of Fireproof Floor Construction. Water Directed on the Ceiling.

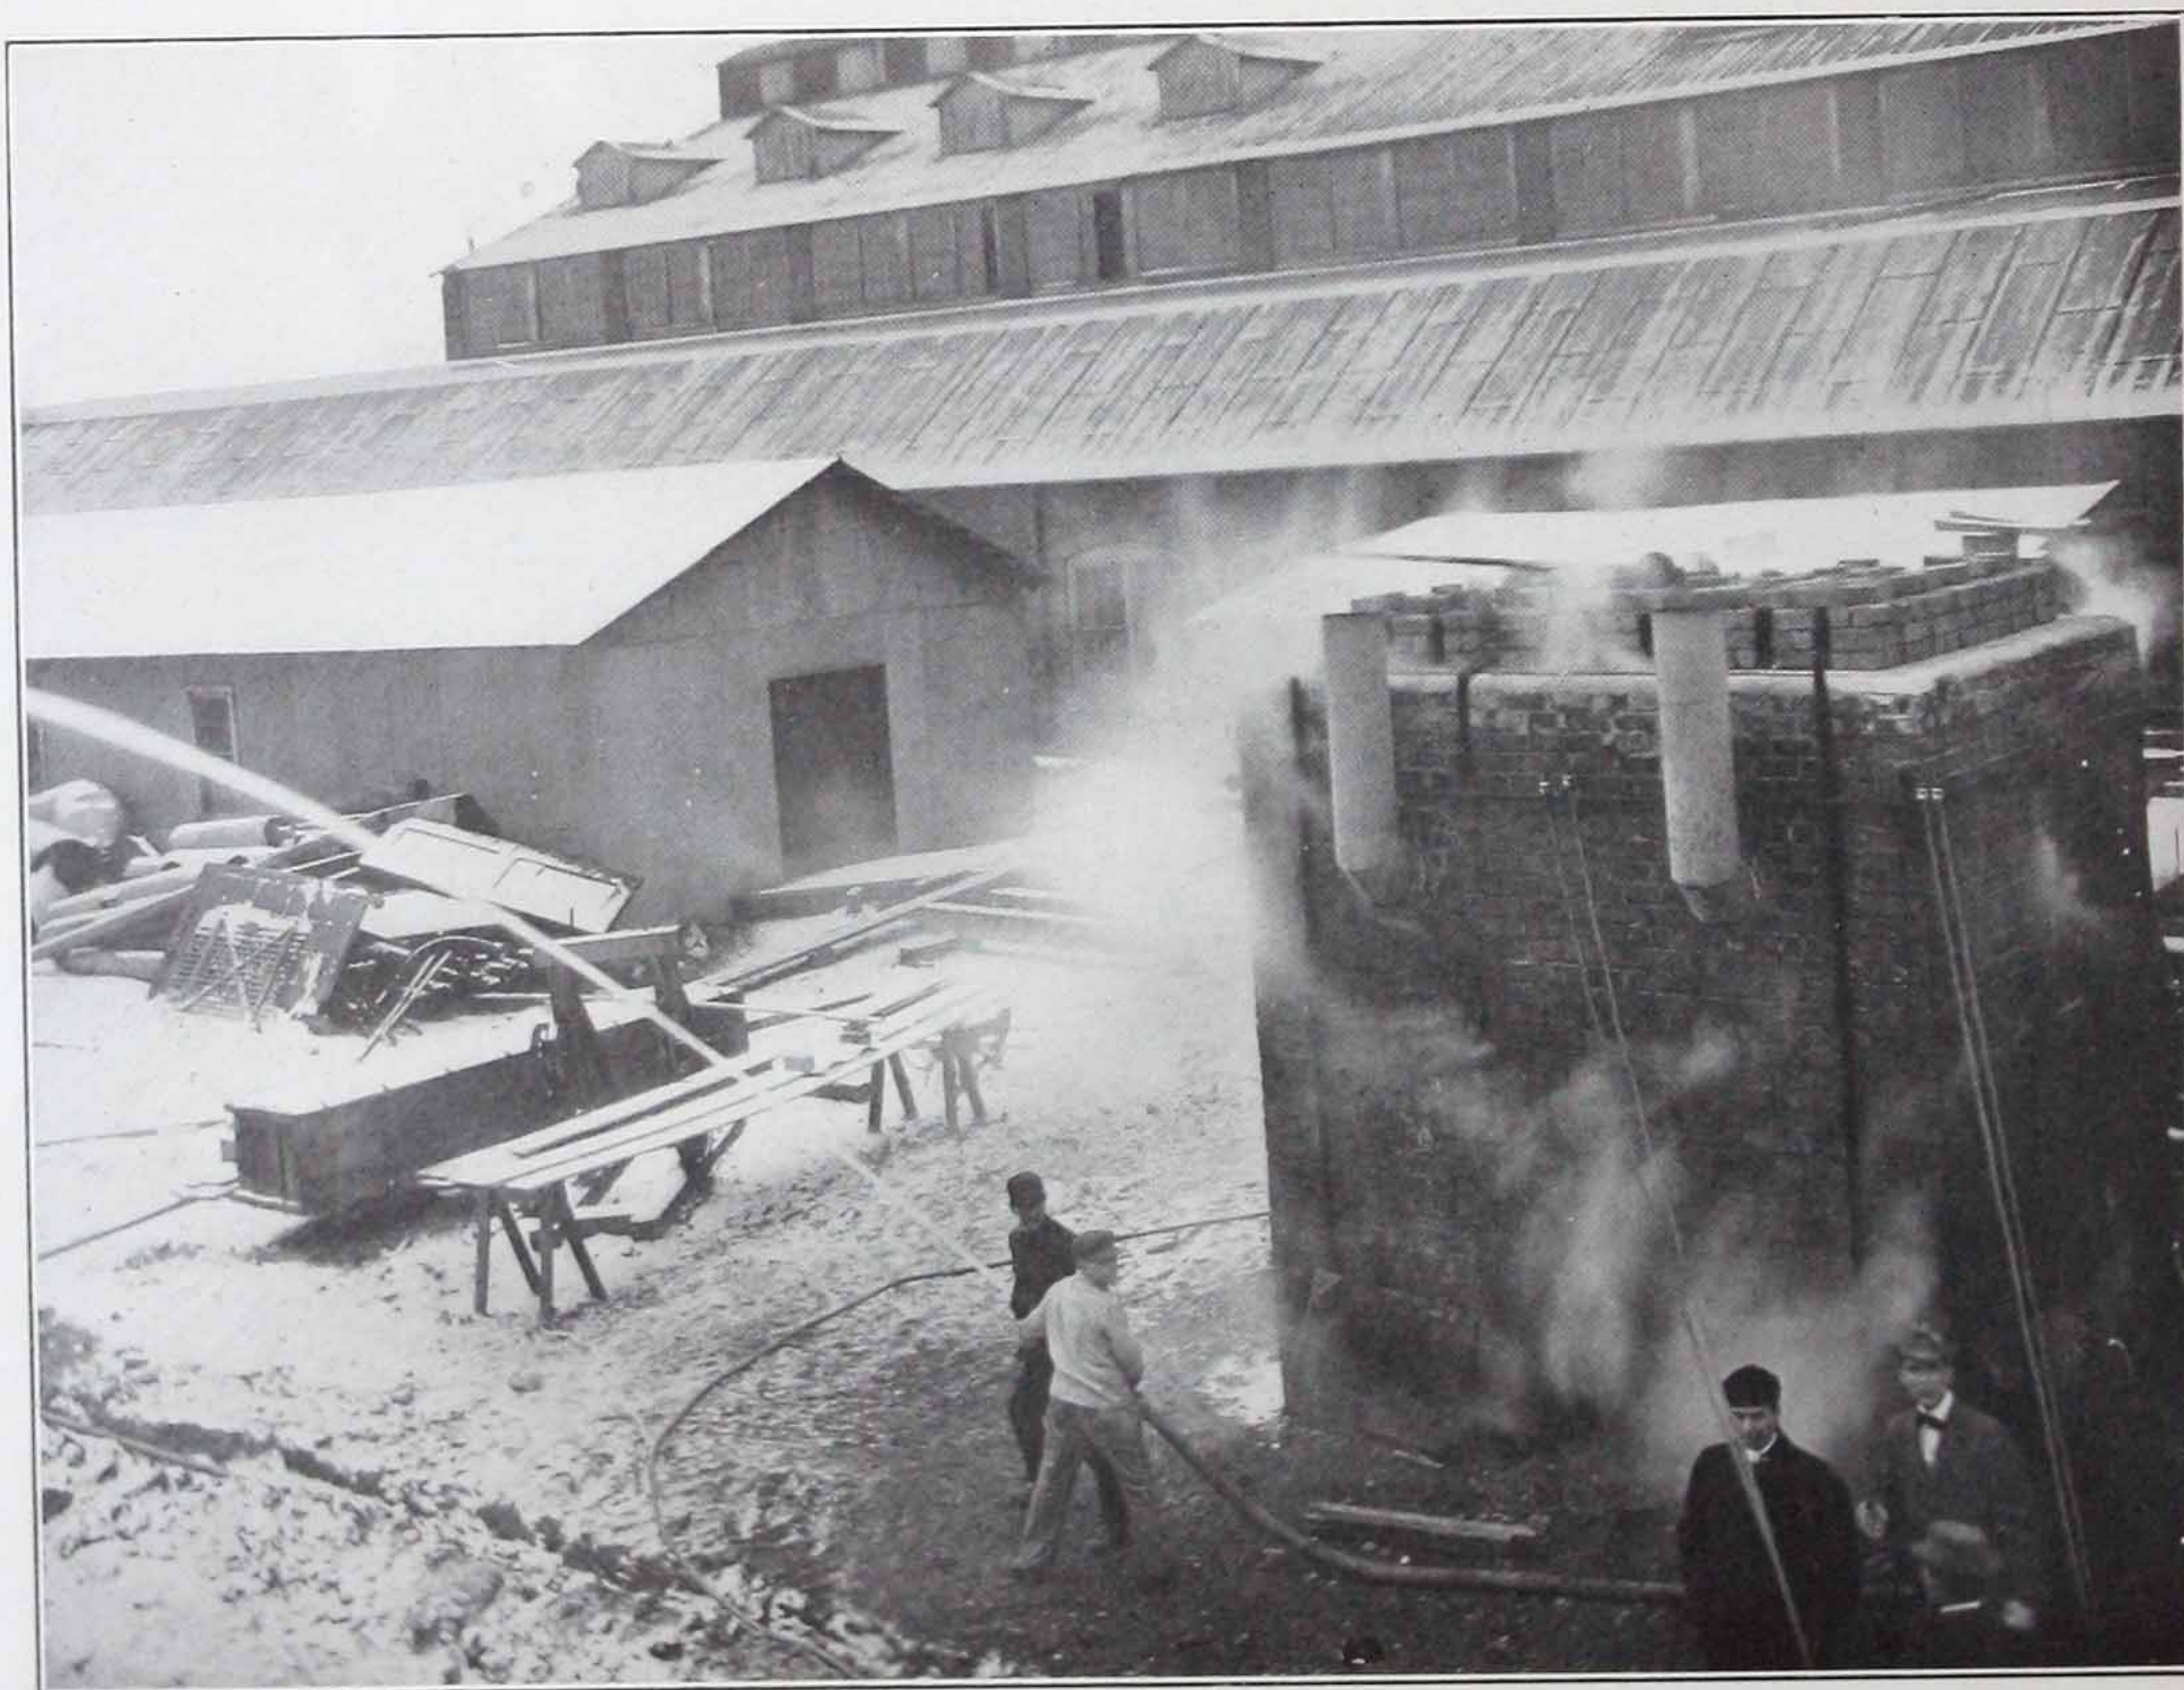
Testing the Water Pressure Before Same was Applied to Ceiling of Furnace After Latter Had Been Fired Four Hours and Ten Minutes. Temperature 1598° F.

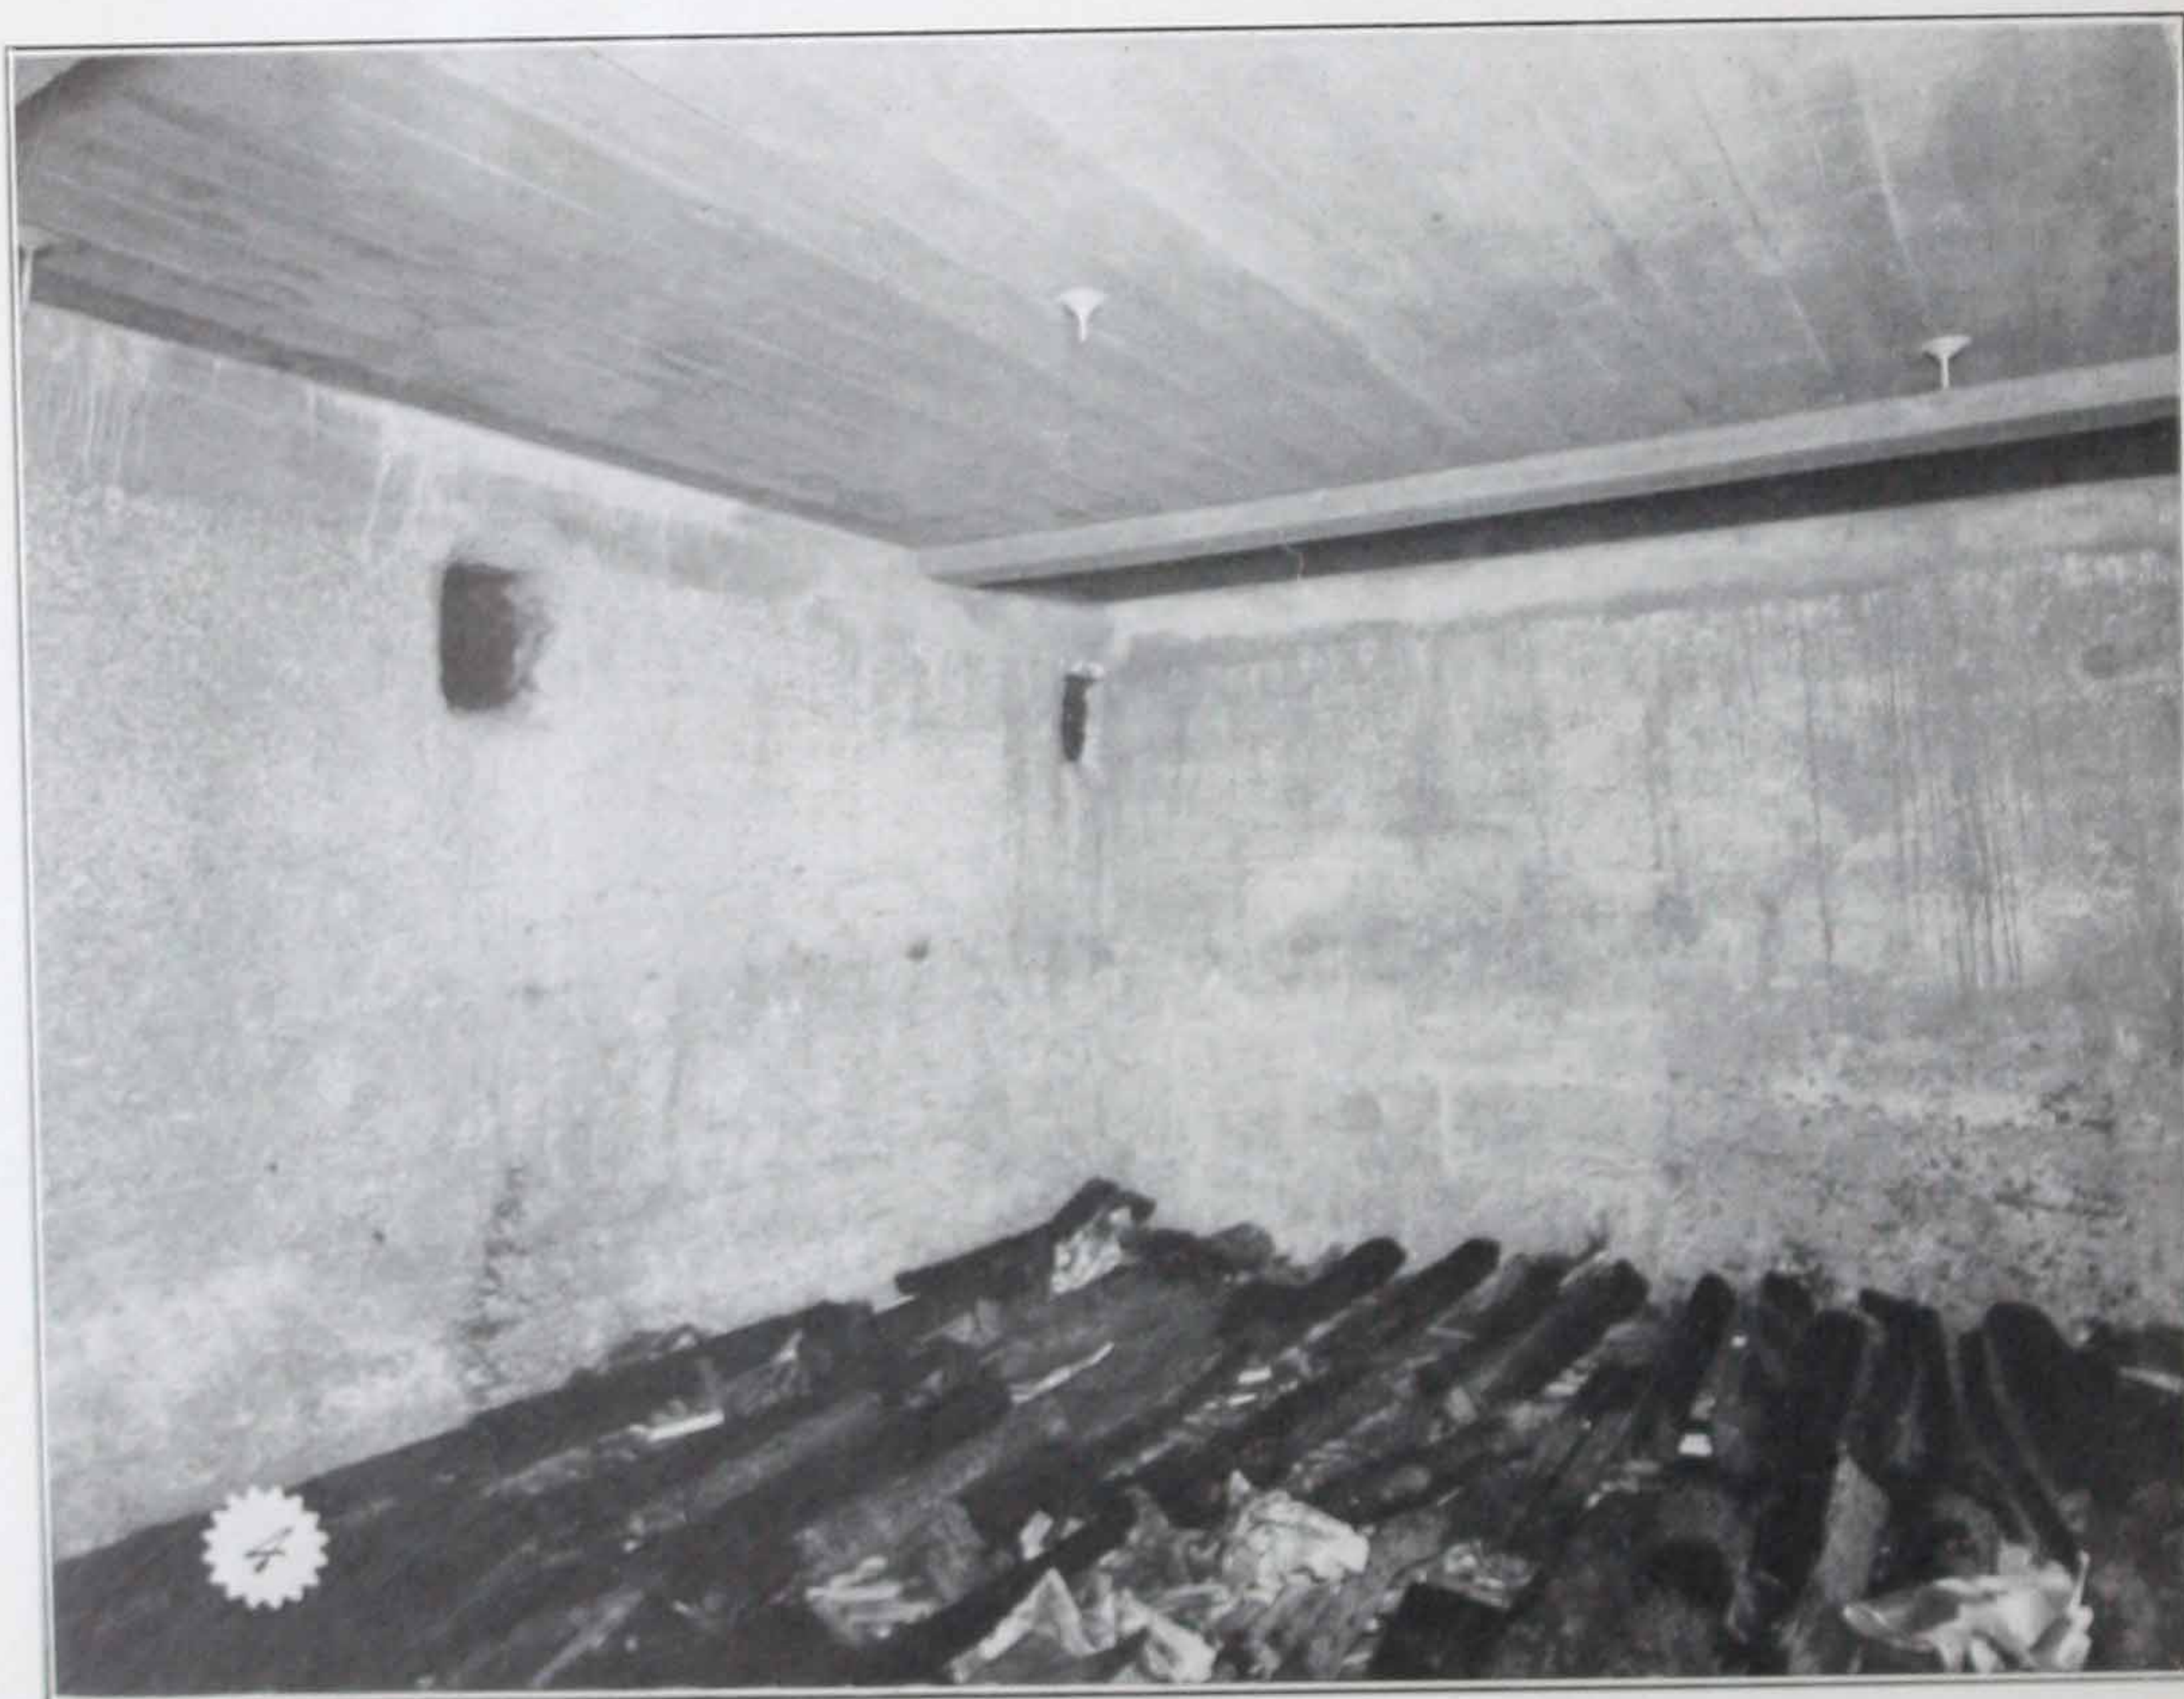
Both installation and test were witnessed by officials from the Bureaus of Buildings of the several boroughs. Floor and ceiling examined just before starting fire. The ceiling contained one small crack, extending from the back of the chamber forward, three feet from the west beam, also a crack five feet from and paralleling the front wall.

Ceiling just Before the Fire Test. Thermo-couples can be seen Projecting Below the Ceiling.

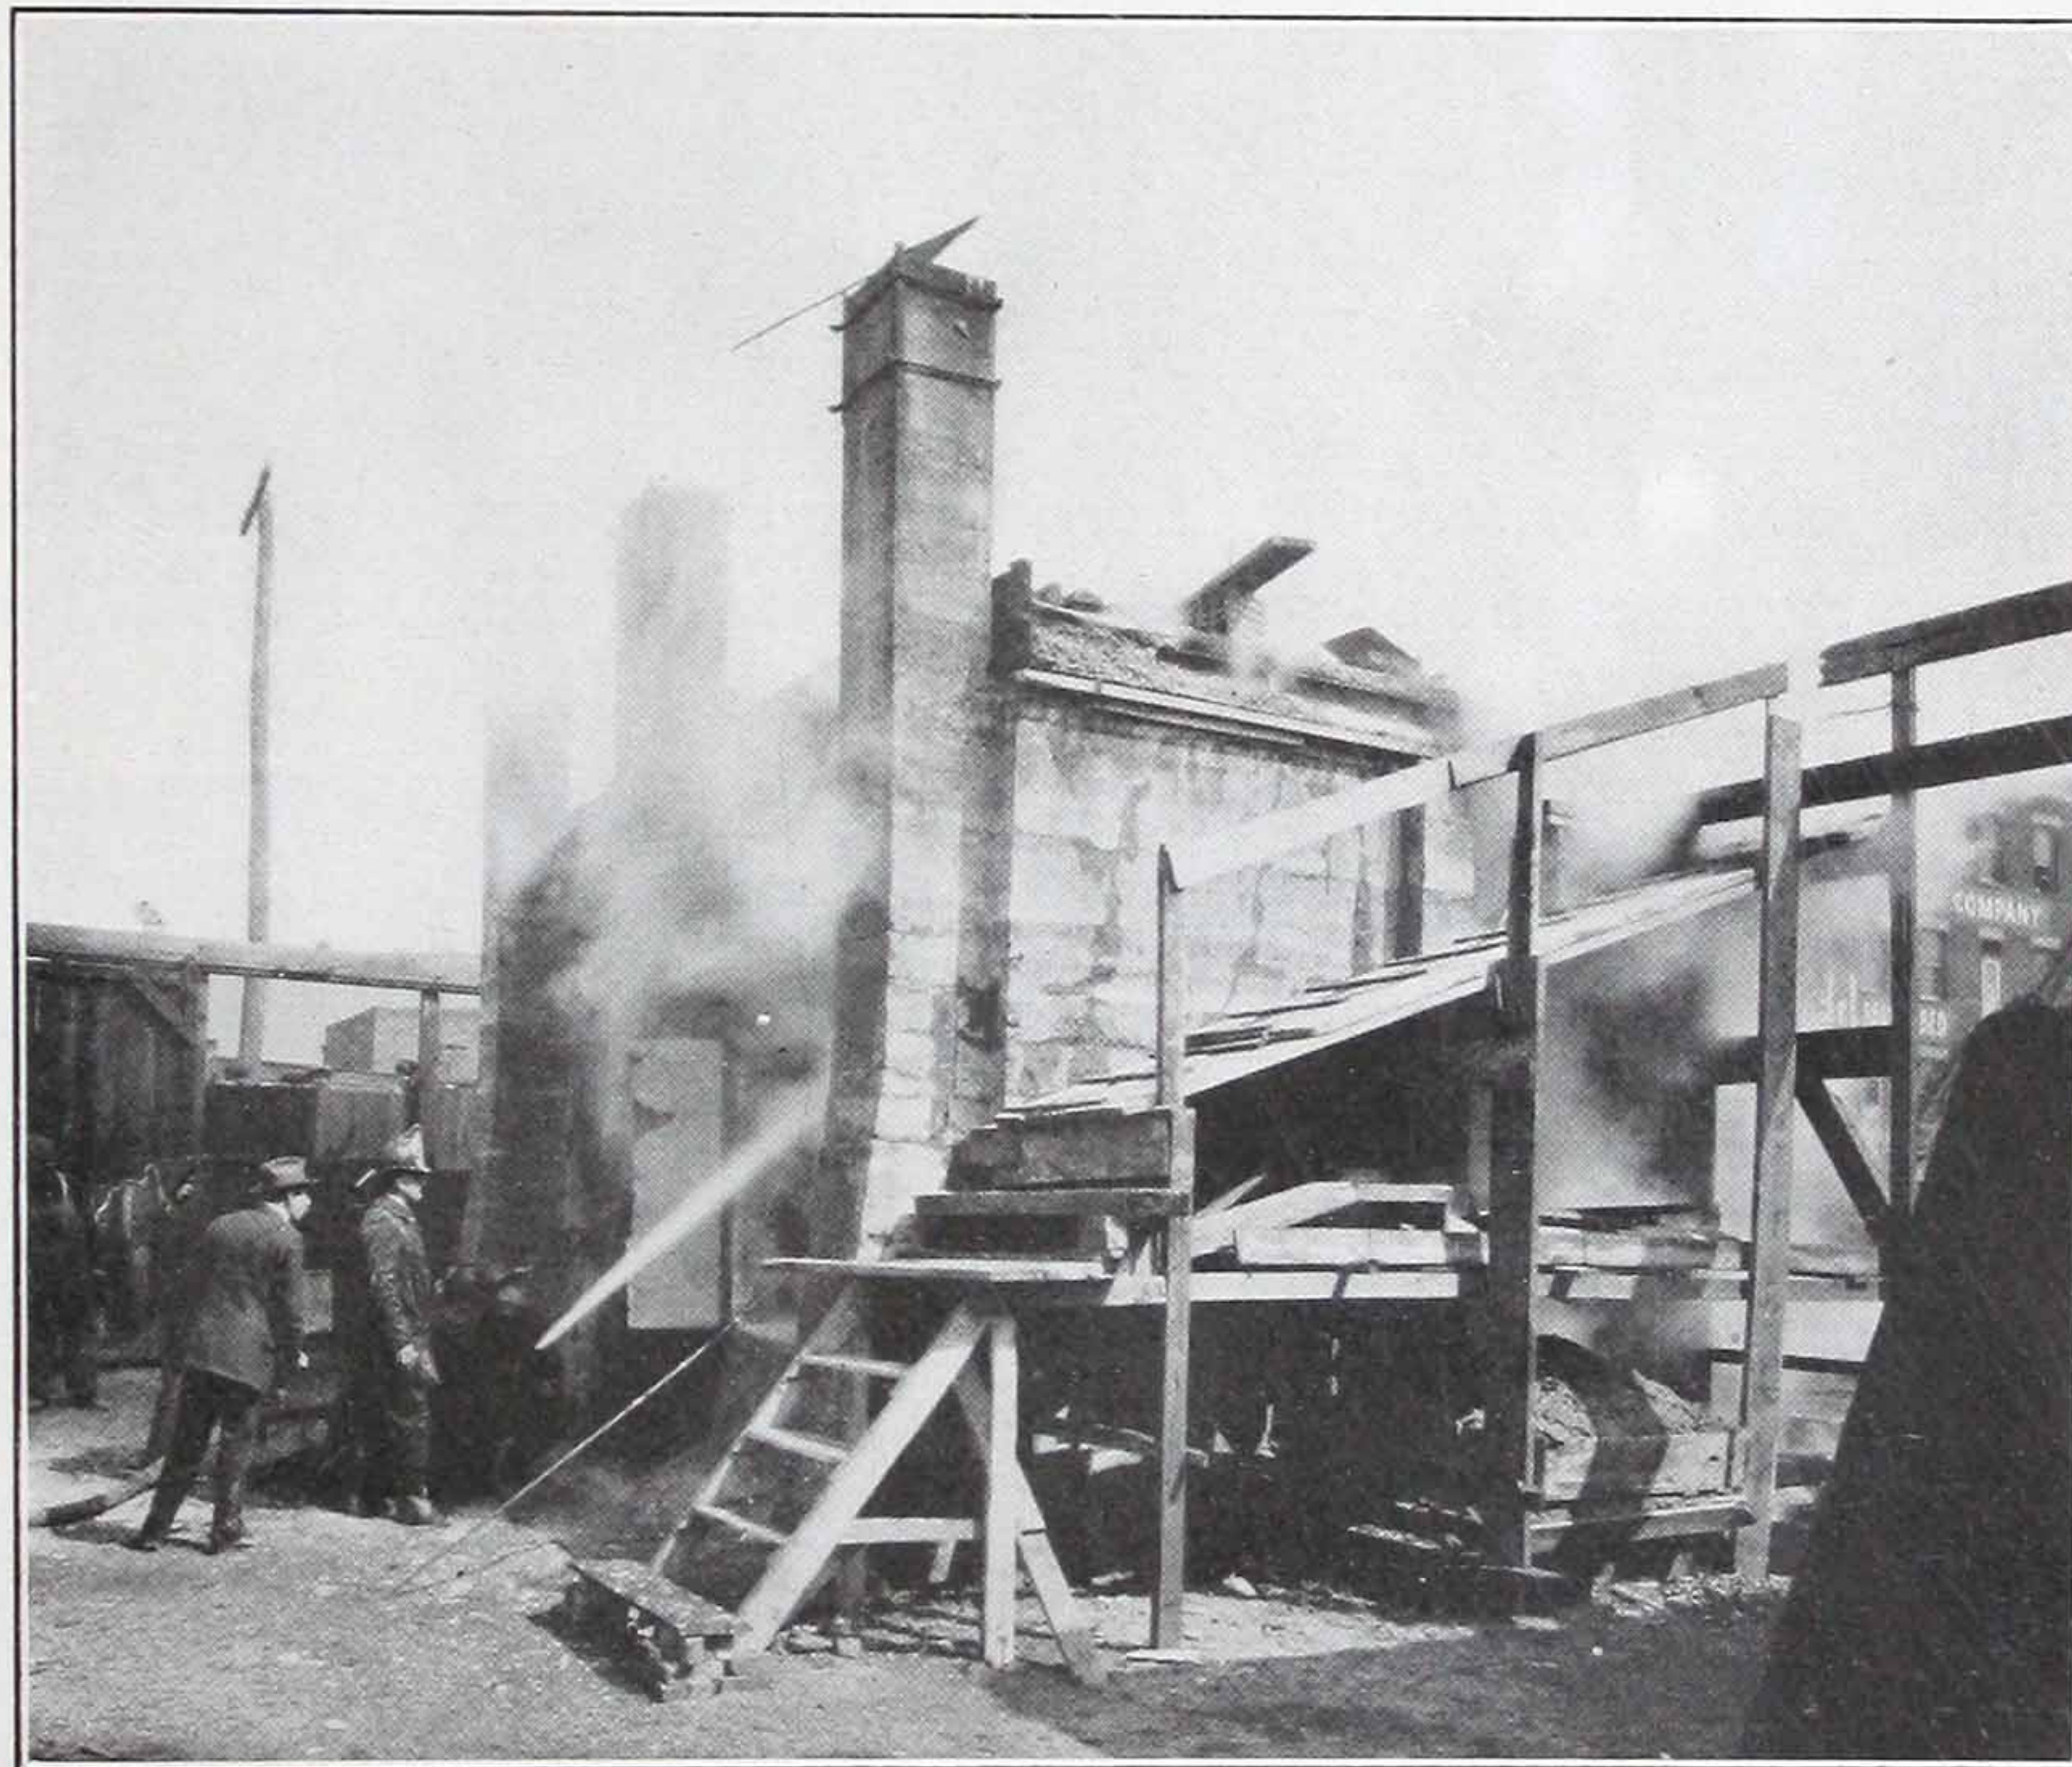
The application of water washed away the plaster coat to a depth of from  $\frac{3}{8}$  inch to  $\frac{1}{2}$  inch. Where cracks existed the plaster was furrowed out to varying depths; the general condition is clearly shown on page 26.

Several other very small areas were exposed. The bare lath after applying water formed about 2 per cent of the total area under test. Along the inner edge of the west beam the lath was exposed for a length of 5 feet to a width varying from 1 inch to  $1\frac{1}{2}$  inches.

Applying the Water After the Fire Test.

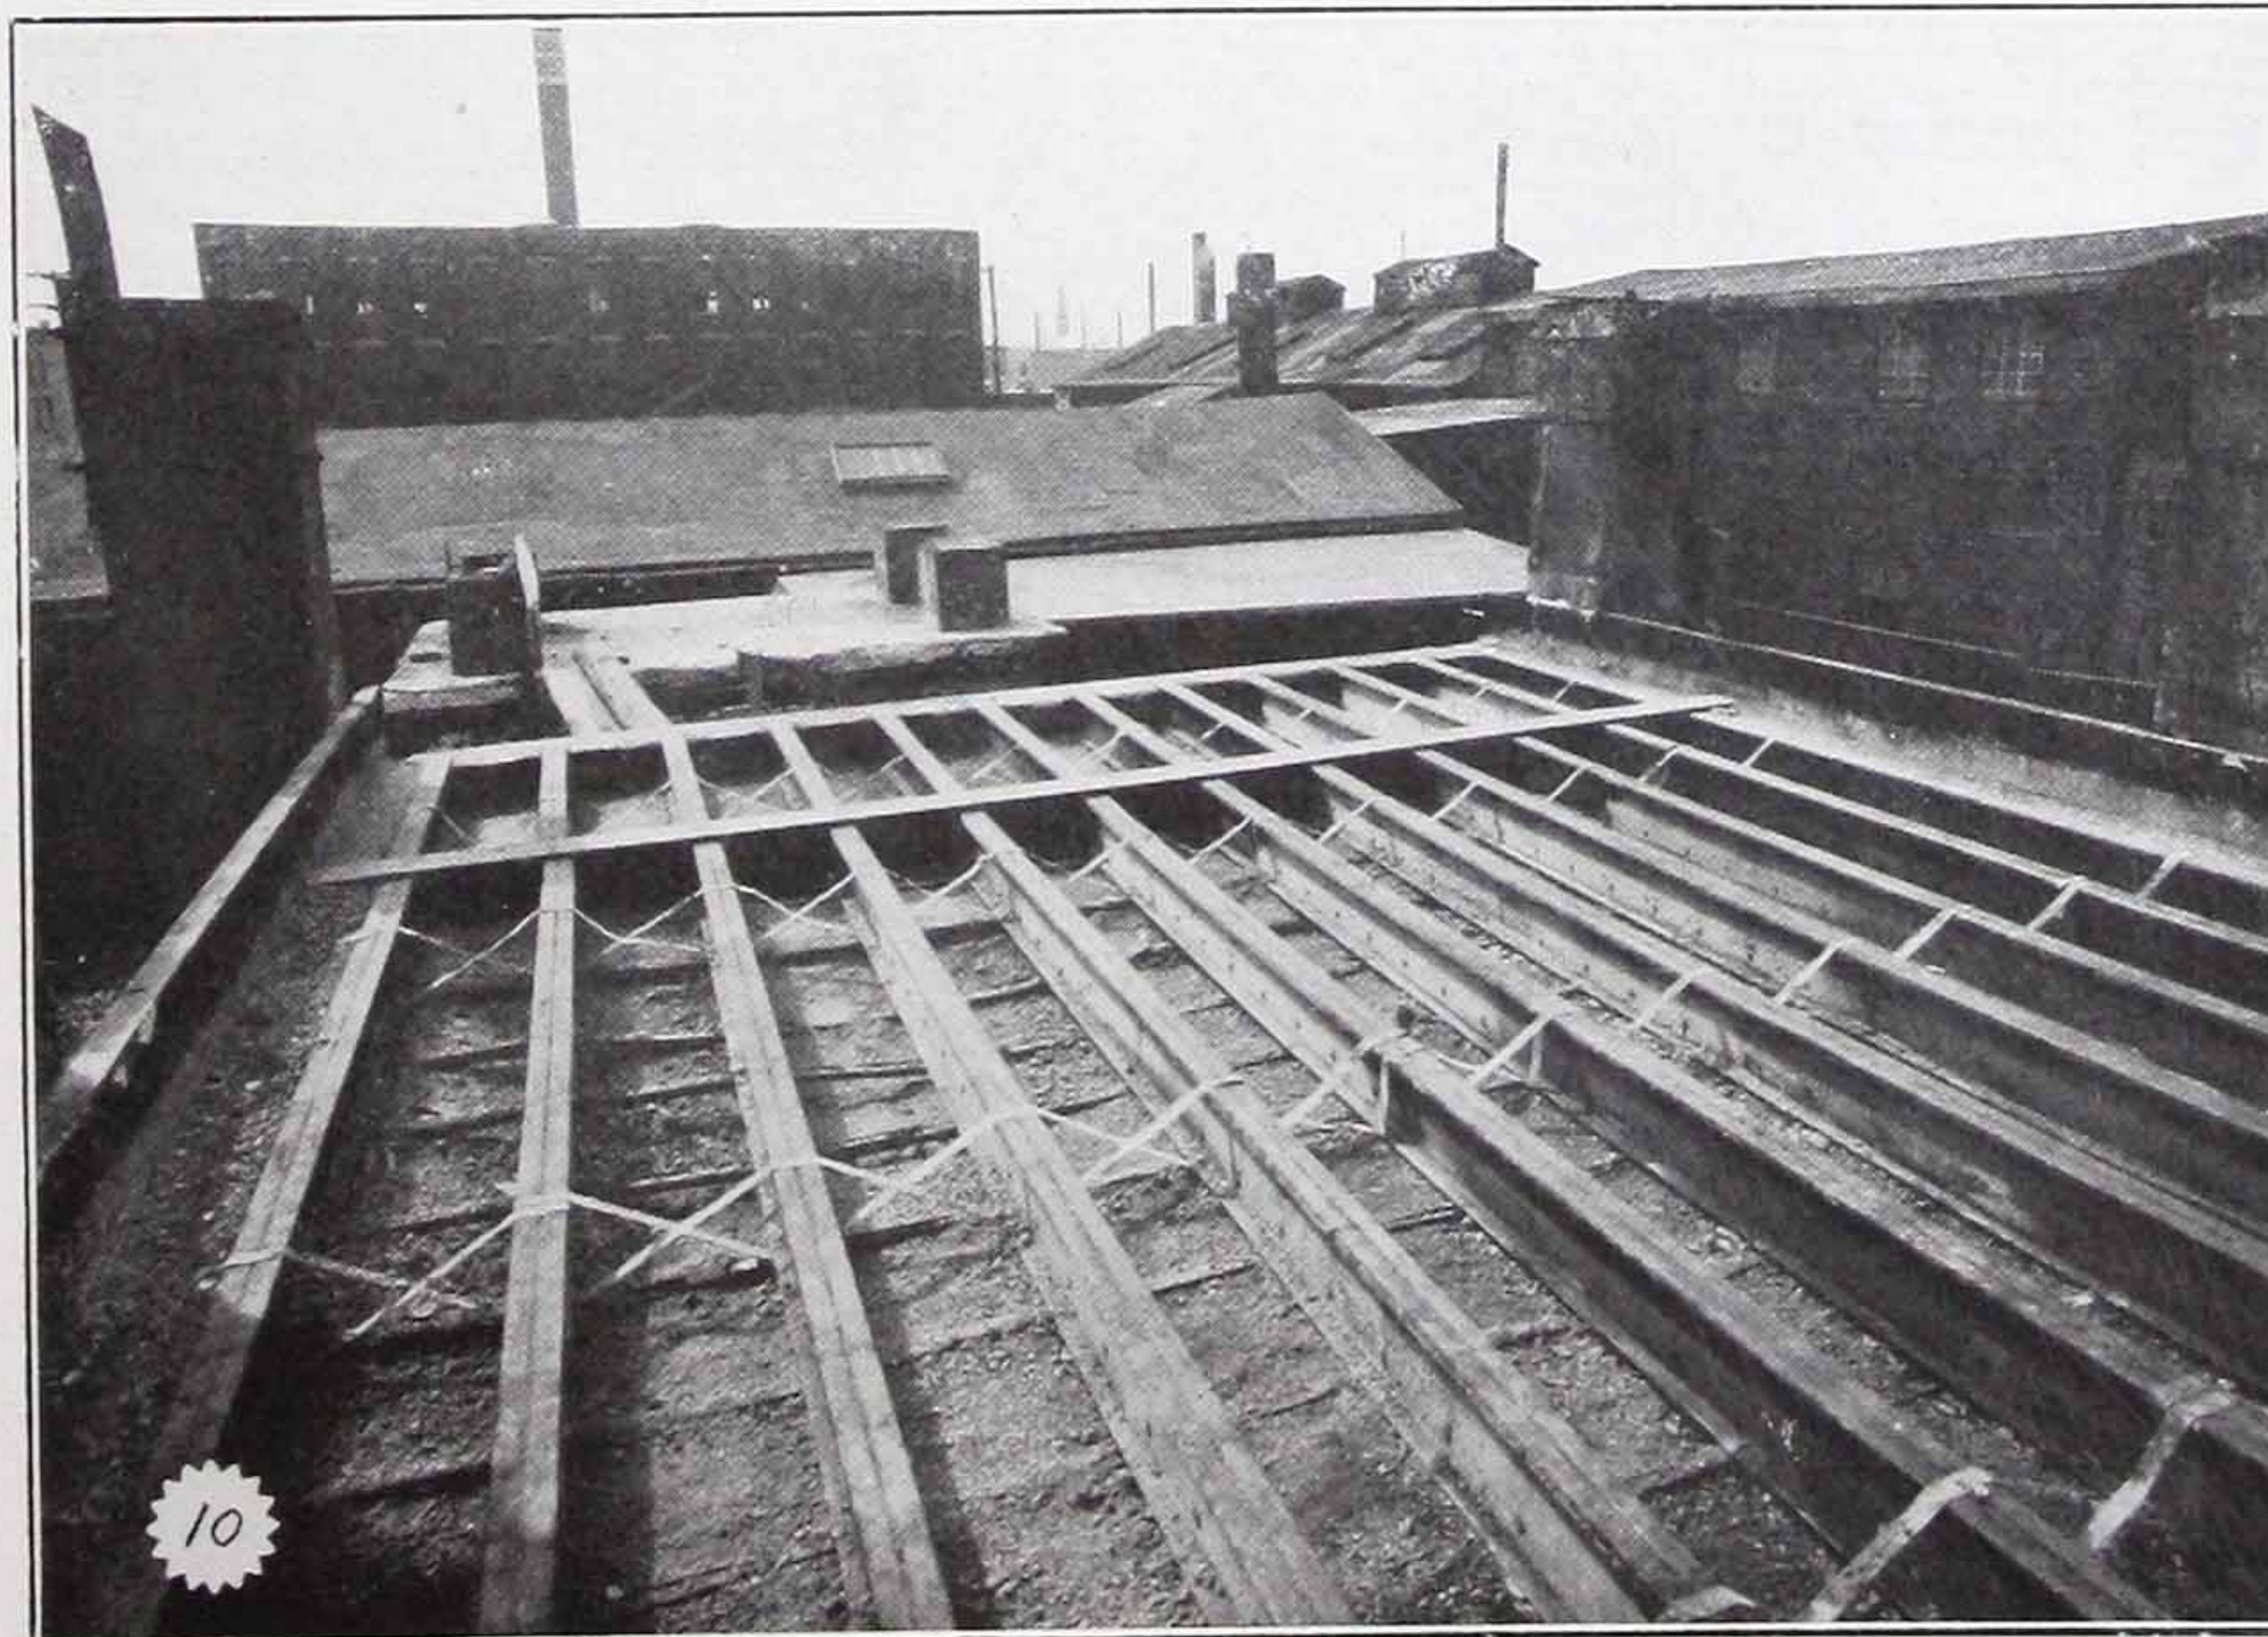
No flame or water came through the floor and but a slight amount of smoke issued from one crack.

View of the Floor System After the Fire, Load and Water Test, the Top Cinder Slab Having been Removed to Expose Joists and Other Details.
